River Restoration in Denmark

River Restoration in Denmark – 24 examples

Storstrøm County, Technical and Environmental Division 2006

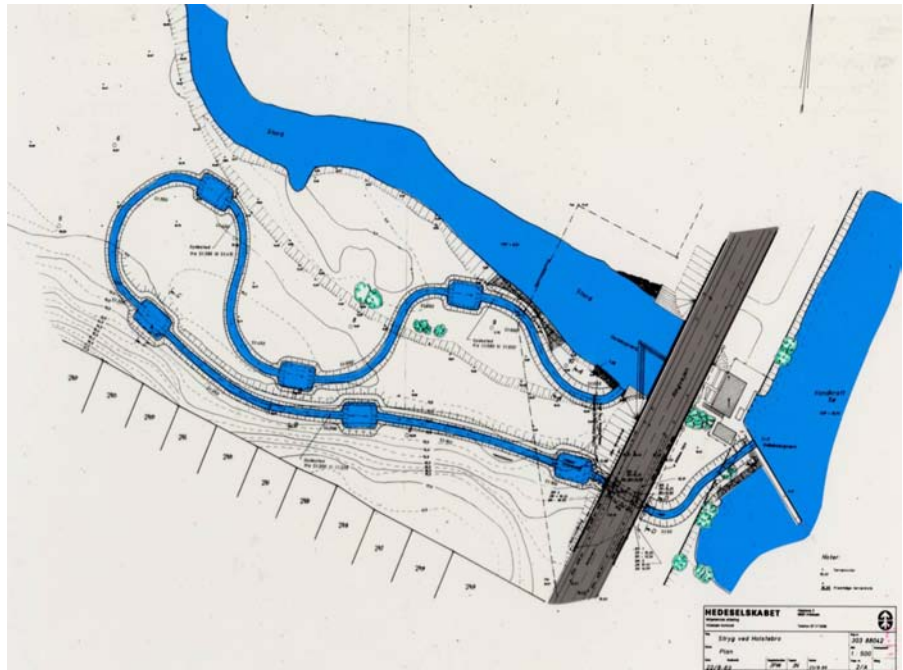
The riffle contained six pools for the fish to rest in, and spawning gravel was laid out in some reaches so that it could also serve as a spawning and nursery ground for the fish. In addition, a screen was established immediately downstream of the turbine outlet.

Design of the bypass riffle at Holstebro hydroelectric power station

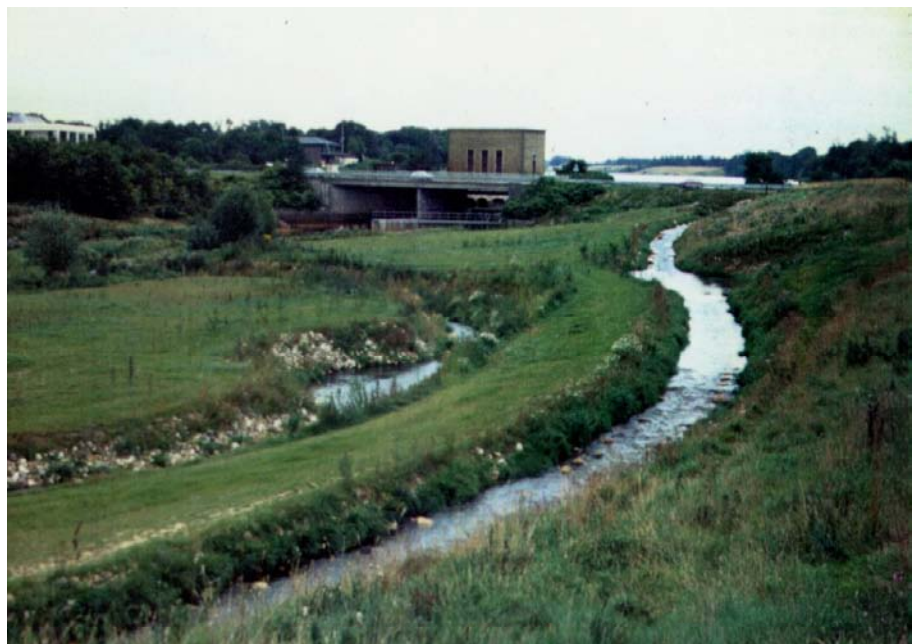
Spawning ground in the uppermost reach of the bypass riffle. In the background can be viewed the hydroelectric power station and its lake.

It was also shown that salmon and greyling successfully spawned in the gravel beds laid out in the riffle, although it was not possible to determine the magnitude of this.

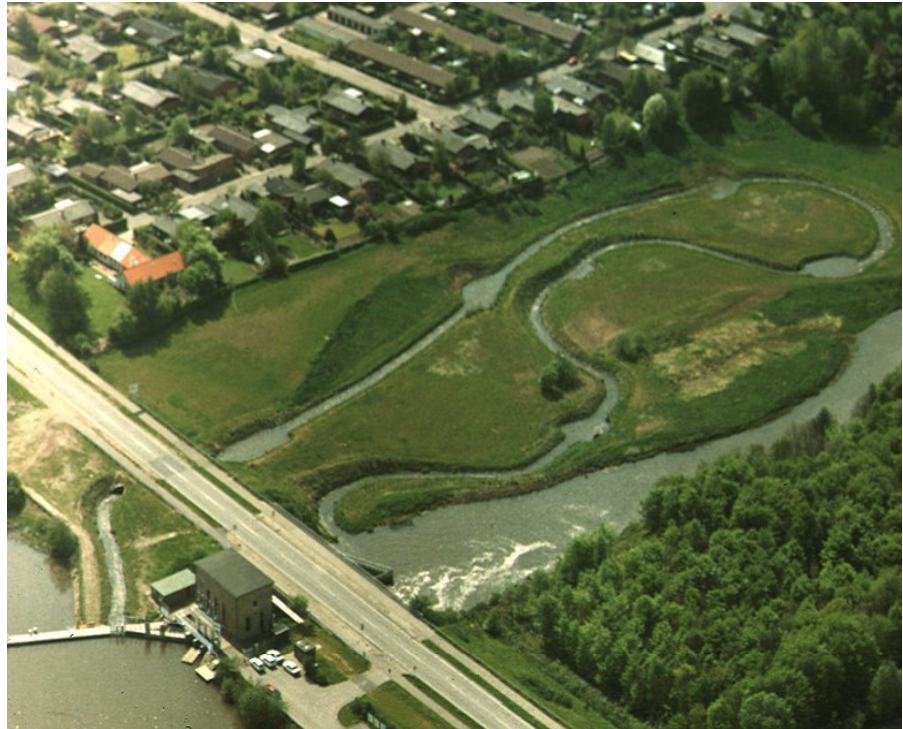
Aerial photograph of the hydroelectric power station during a situation with high flow through the sluice and turbine

It is noteworthy that high water flow and operation of the sluice, which appear to completely or partially mask the attraction flow from the riffle, do not have any negative impact upon the passage conditions (see the photograph below).

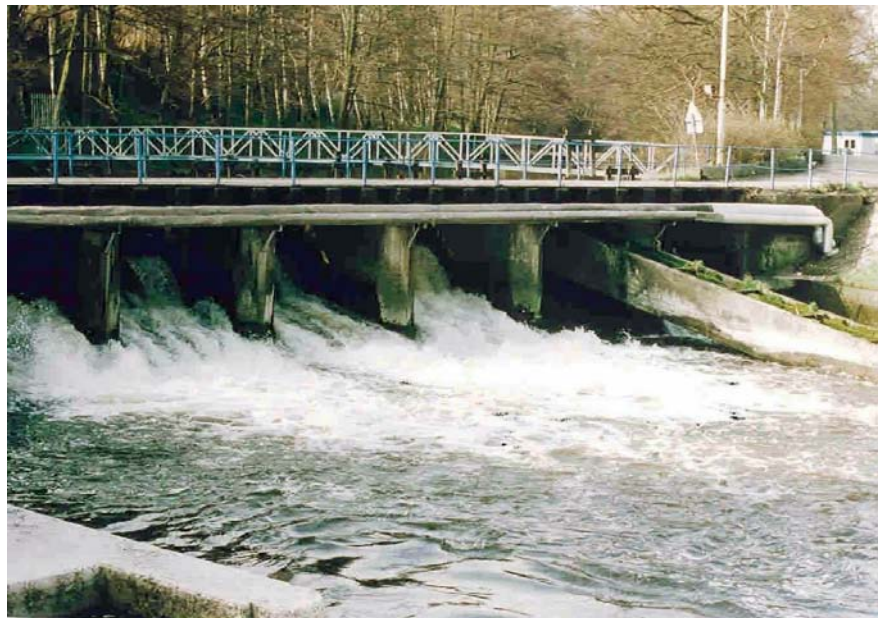
The dam prior to establishment of the fish pass

The difference in river level across the dam was almost 3 metres prior to carrying out the project.

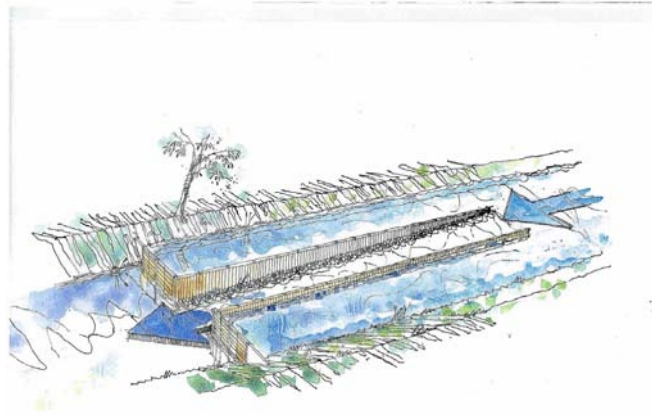
When water flow in the river Odense is low, all the water flows through the upstream end of the riffle (see the drawing above).

The upstream riffle is located between two retaining walls in the middle of the river Odense. This solution was chosen so as to ensure an unchanged soil water content under the paper mill buildings, which are built in the actual river valley.

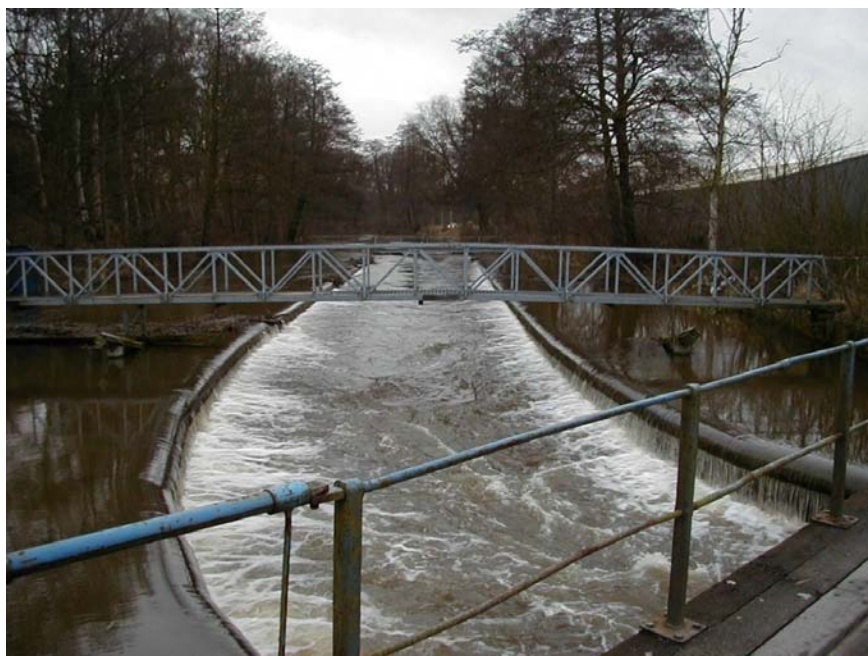
The riffle during medium water flow

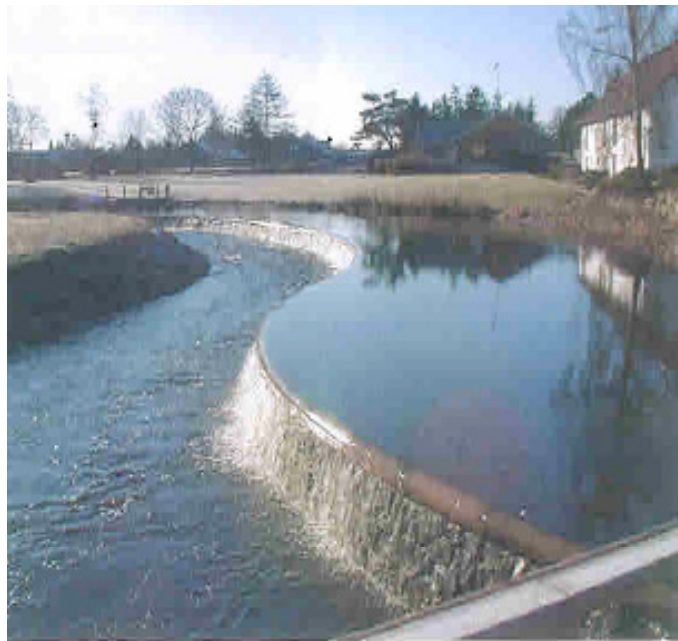
Fish pass at Brobyværk

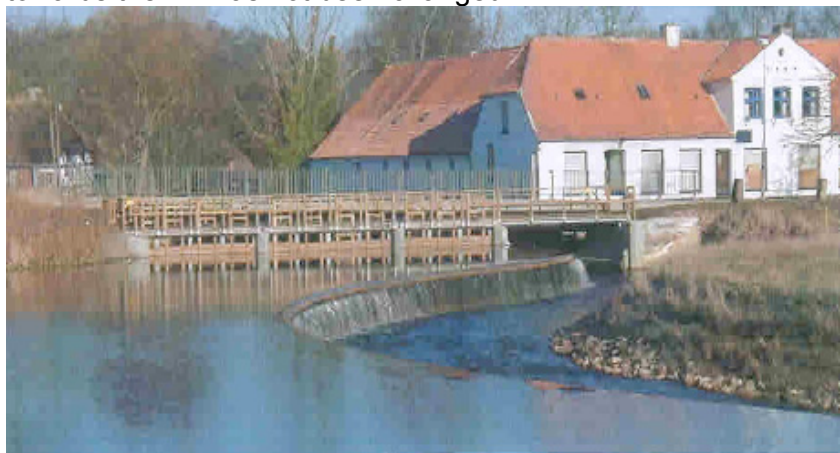
Mean water flow

A new maximum river level applicable all year round has been set at 23.06 m above Danish Zero Level (DZL). The minimum river level applicable all year round has been set at 22.70 m above DZL. The upper edge of the retaining wall is 22.8 m above DZL.

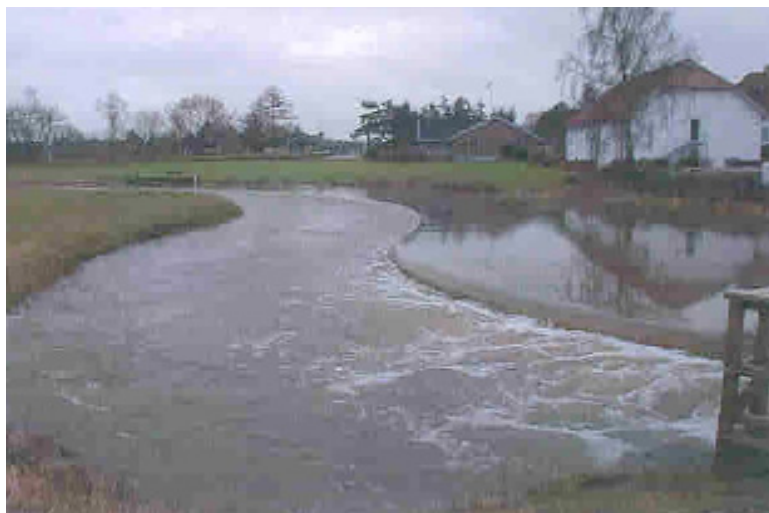
High water flow

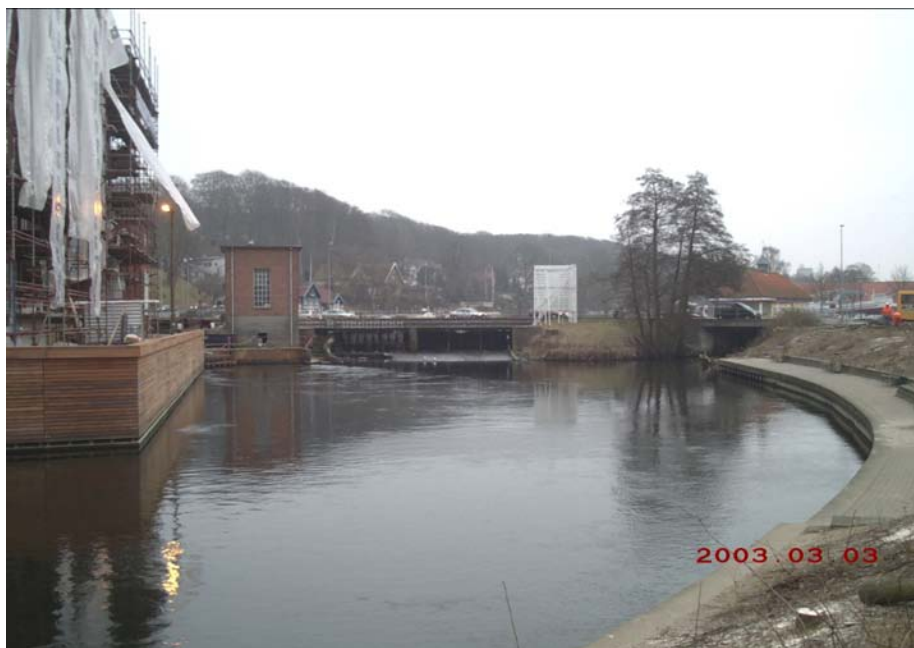
The weir before establishment of the fish pass

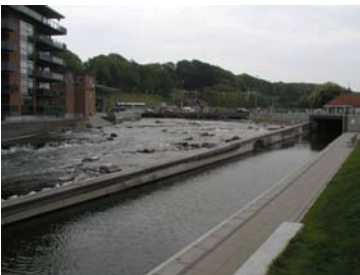
The navigation channel alongside the riffle

The weir gates are made of stainless steel, the riffle is built up of large stones, the restraining wall alongside the navigation channel is made of sheet iron piling that has subsequently been clad with certified tropical timber.

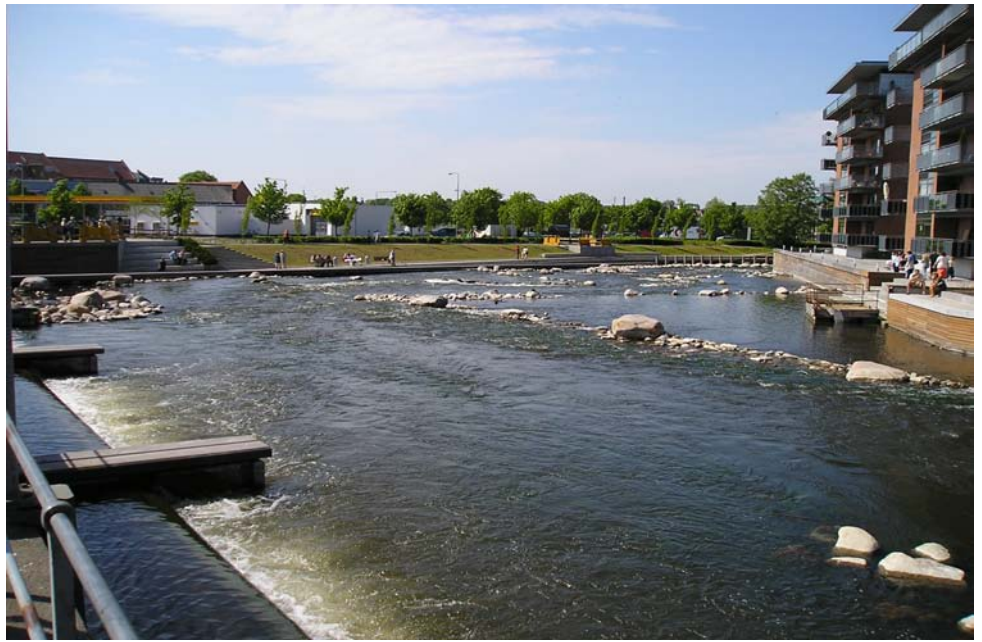
The new weir and the fish pass viewed from downstream

The main technical challenge posed by the project was not the size of the stone riffle, but to control the river level. In designing the project a weir construction was therefore developed with weir gates built into the bottom of the riffle inlet. A combination of a fixed opening and three 10-m long variable weir gates enables the river level and hence the water level in the harbour to be maintained with a variation of only a few cm at water flows ranging from approx. 5 m³/s to approx. 36 m³/s. In designing the construction, considerable consideration was given to operational reliability and handling during extreme conditions.

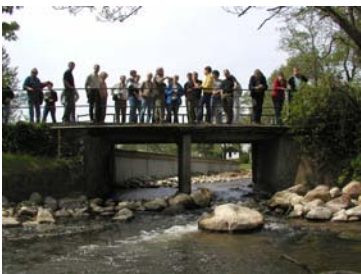
After removal of the weir

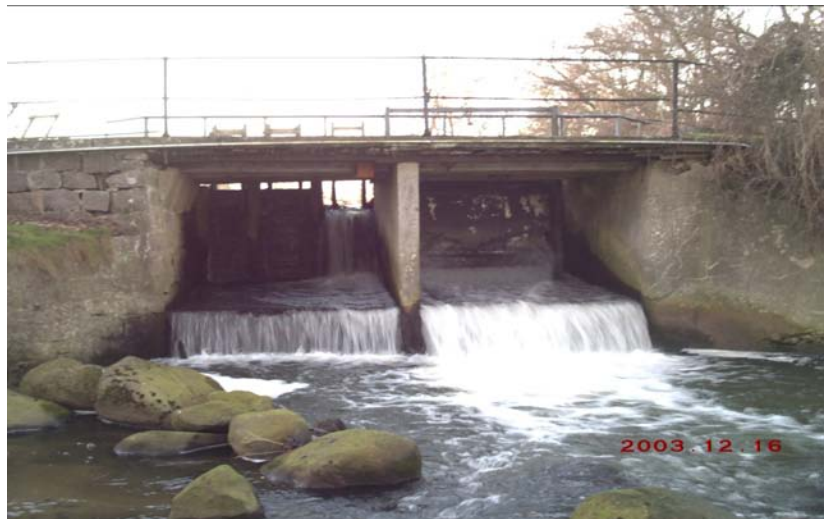
As the buildings at Tarskov Mill are worthy of preservation and as the interplay with the millpond is of great architectural value, it was decided to construct a new river bed (stone riffle) as a separate part of the millpond. The project thus encompassed to main elements: Re-establishment of the millpond and construction of a new stone riffle in part of the millpond.

Before removal of the weir

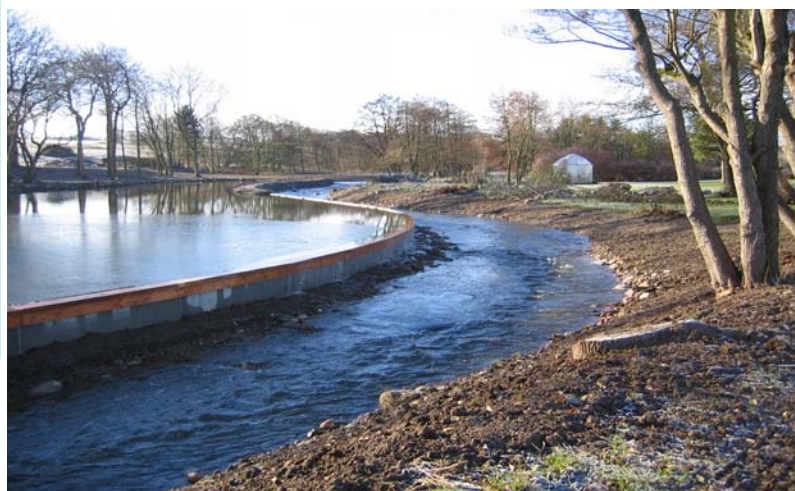
The millpond is supplied with an average of 50 l/s via an intake from the river whereafter the water is led to the original millstream. The impression of a mill environment is thus preserved.

The millpond and the upper segment of the new stone riffle

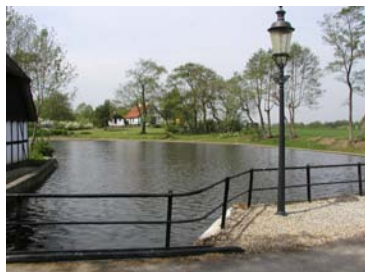
The millpond with the stone riffle running alongside the trees

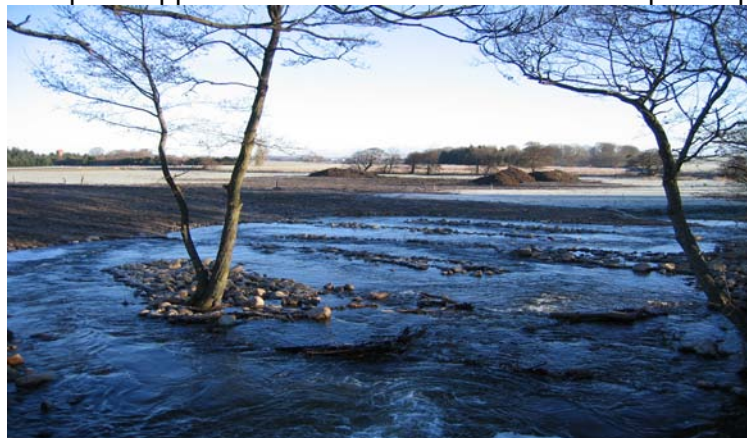
The approx. 2.5 m height difference is evened out by an approx. 300 m long stone riffle constructed as two different but contiguous segments. The upper segment of the riffle is approx. 200 m long with a slope of approx. 8‰. This runs between the retaining wall and the original bank of the millpond and is 4 m wide with a 1 m wide gently meandering current channel in its bed. The lower segment of the riffle consists of a very compact and extremely meandering stone riffle with a slope of approx. 18‰ and a current channel slope of approx. 10‰.

The lower segment of the new stone riffle

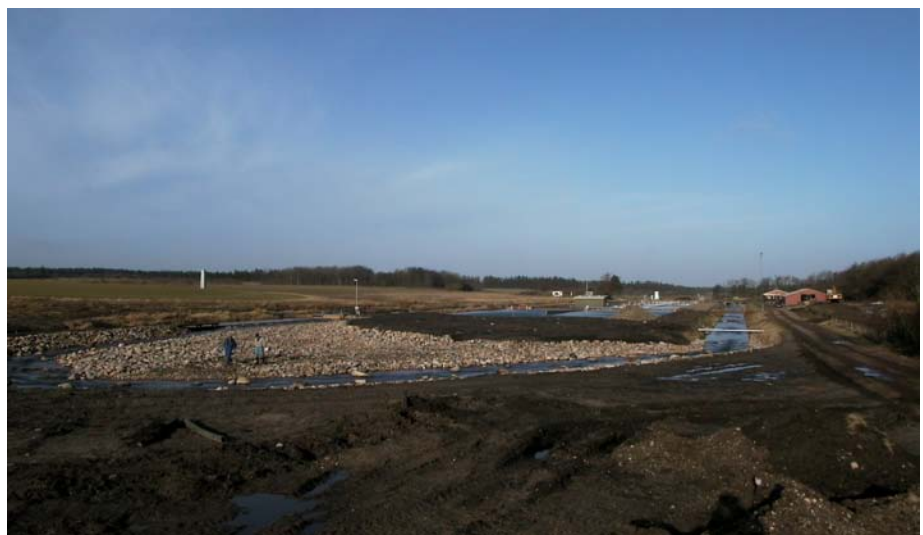
The high transport capacity of the riffle is largely attributable to the weir's approx. 25 m long spill crest and the extremely wide spillway in the uppermost section of the riffle (see the photograph below of the new fish pass).

The newly established fish pass at Gryde Fish Farm

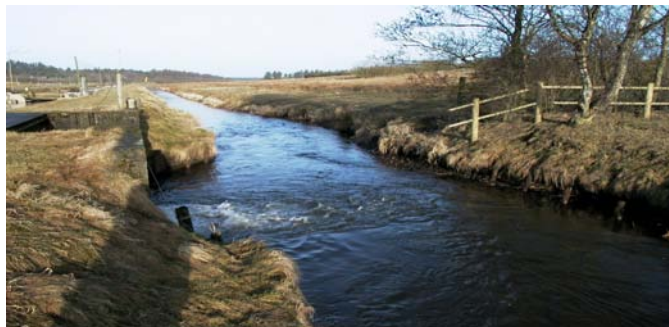
Before this alteration the water flowing through the outlet from the fish farm reached right over to the opposite bank of the river with great force. After establishment of an approximately 4-fold wider outlet the false attraction flow does not even reach to the centre of the river (see photographs below).

Prior to alteration of the fish farm's outlet

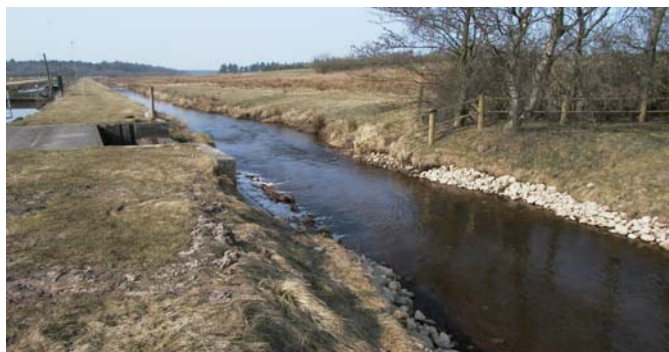
After alteration of the fish farm's outlet

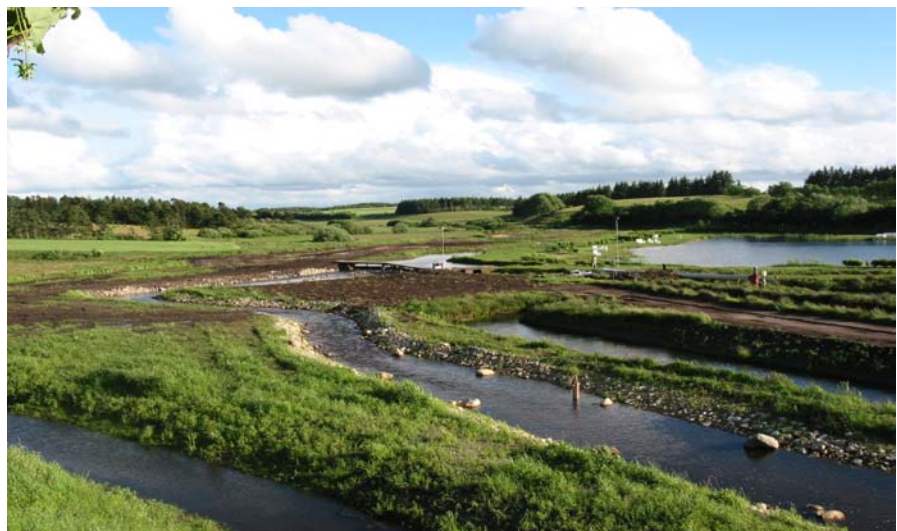
The new riffle has been led down past the fish farm's new water outlet, which has also been relocated in connection with the project. Approximately 20 m of spawning ground has been laid out in continuation of the riffle.

The new fish pass at Munkbro Fish Farm in the river Vegen

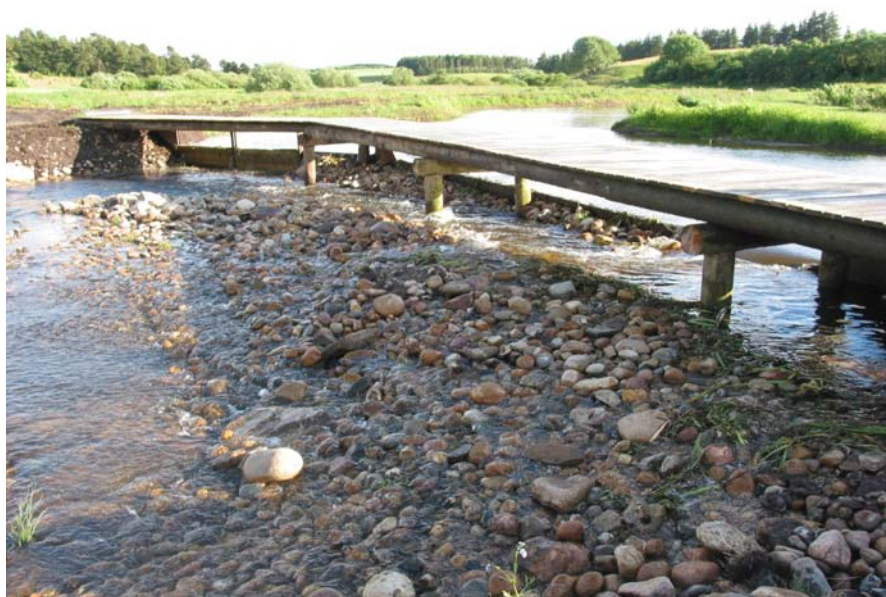
Alternative fish screen at Munkbro Fish Farm

A new feature at Munkbro Fish Farm is the establishment of a means of screening out the wild fish from entering with the river water flowing into the farm. The new screening system, which is a sort of “reverse biodrum”, is intended to ensure favourable downstream passage for invertebrates and fish larger than 3 mm in size.

Munkbro Fish Farm's new 3-mm screened river water intake screen designed to ensure optimal downstream passage of smolts, etc. The view is from the river looking upstream. The water for the fish farm is drawn from the side of the biodrum screen.

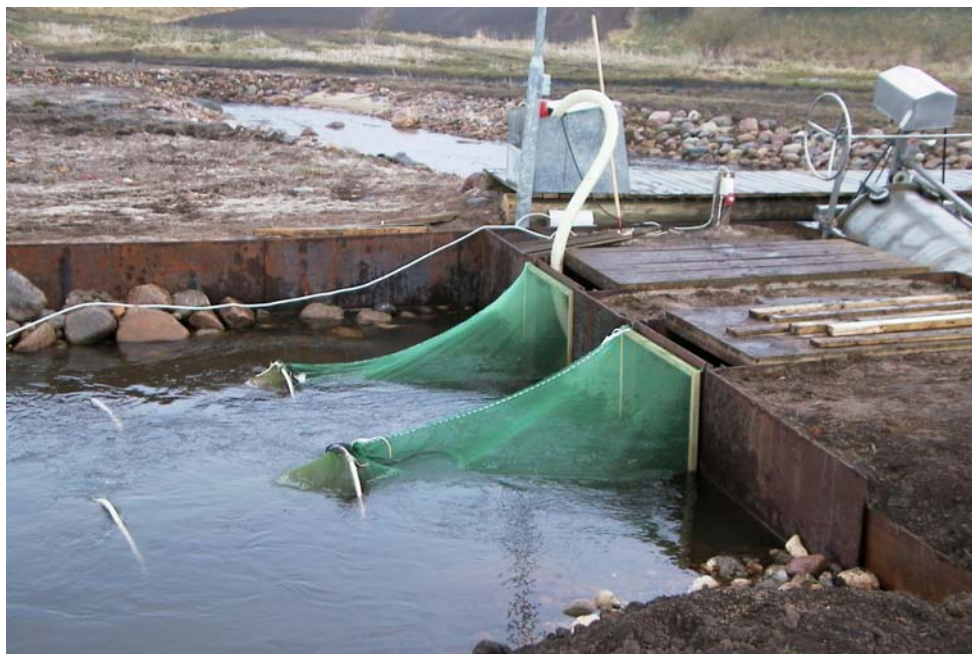
The preliminary results of the study carried out of descending trout and salmon smolts showed that the fish screen on the river water intake functioned virtually flawlessly. Of the 500 smolts released upstream of the fish farm, none were caught inside the fish farm. See the photograph below of trapping studies in the feed canal.

Fish traps in the intake to the fish farm. The biodrum screen can be seen on the right, and the riffle in the background

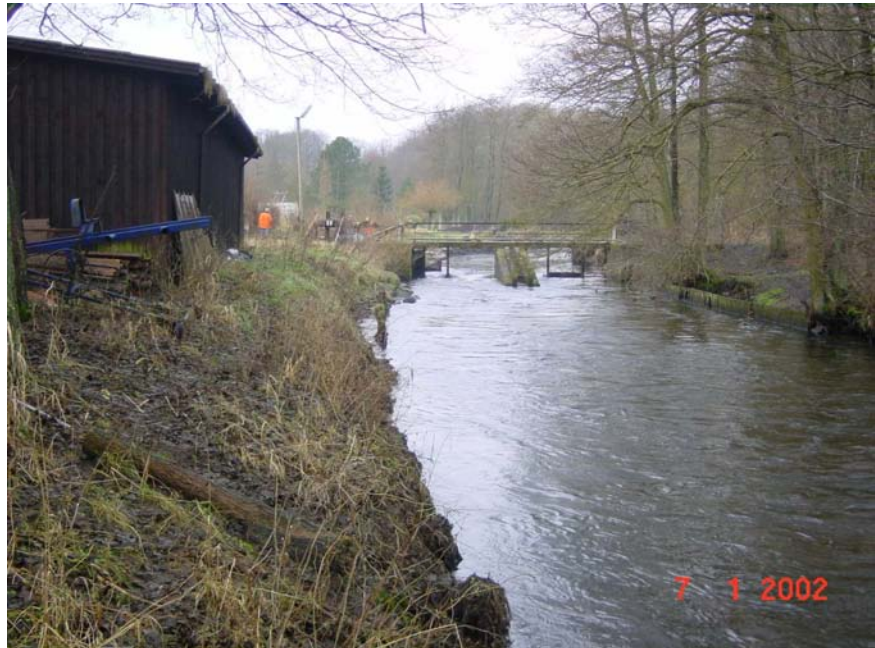
The weir and fish ladder after the river level had been lowered

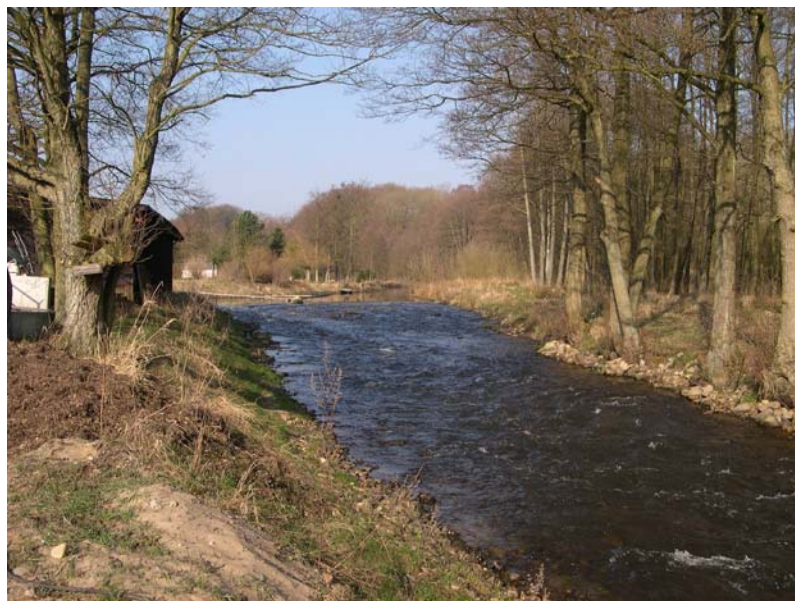
Quite a few canoes navigate the reach. In order that they can sail through and to ensure that the fish pass remains open during low water flow a 4 m wide current channel has been established with a permanent water depth of at least 0.5 m.

The current channel

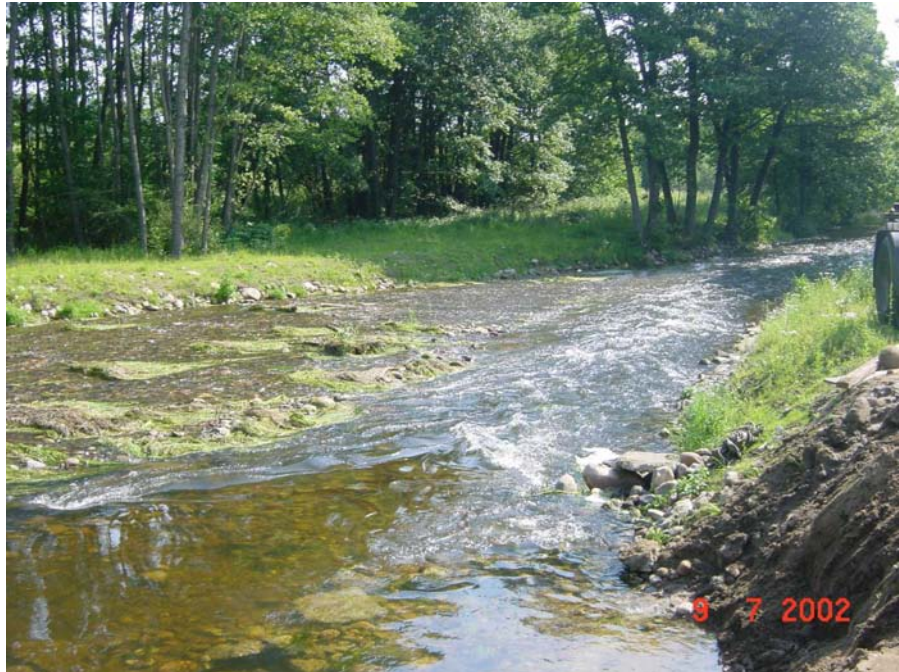
Riffle length: 100 m
Riffle width: 8 - 12 m
Slope: 10‰
Stone laid out: 700 m³
Gravel laid out: 100 m³

The current channel and overflow basin.

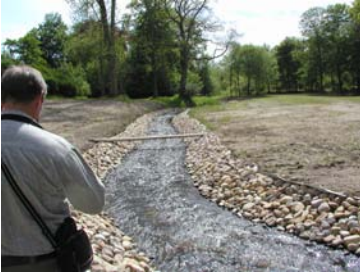
Newly established stone riffle

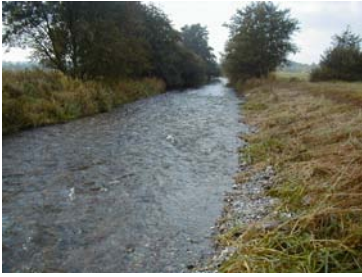
In connection with regulation of the river Sneum in 1955 the difference in elevation between the regulated and the unregulated upstream segments of the river became so great that a double fall was established with a combined drop of about 1.5 m.

Some 15 years ago the double fall was converted to a stone riffle to improve passage conditions for houting. In connection with this, a short reach of the river downstream of the new riffle was re-meandered and the riverbed was raised. The stone riffle was constructed in a manner typical for that time, with two short riffles with a slope of 10‰ and 15‰ and the whole structure protected with large boulders.

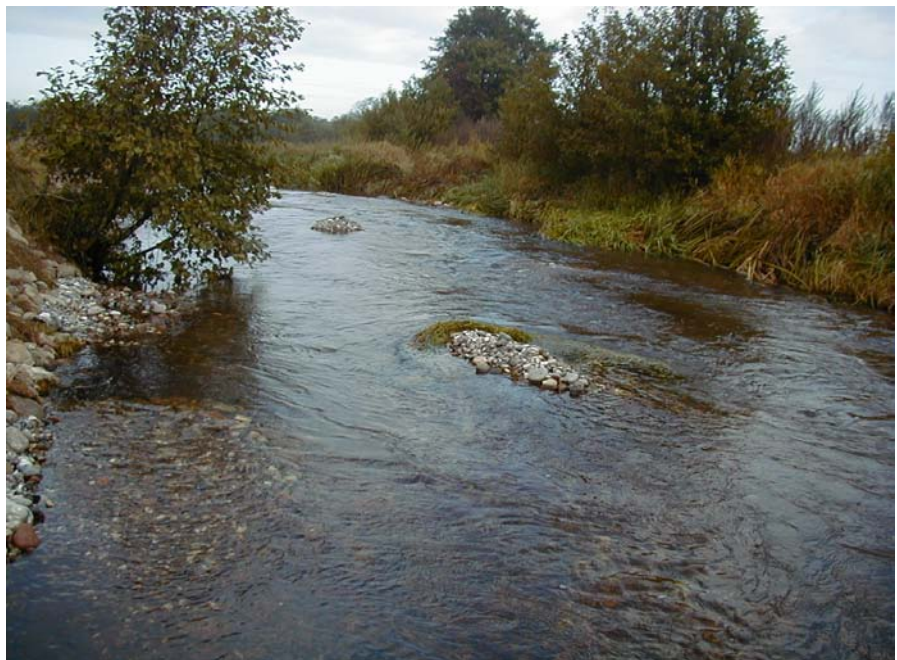
In order to meet the requirement for effective fish passage and optimal spawning grounds for seatrout and salmon the riffle was rebuilt to its present form in 2003. The total length of the new riffle is approx. 220 m, and it consists of two segments separated by a deep section. The deep section arose by the erosion of the bed and banks of the old riffle. The erosion pool was preserved as it offered the advantage that the riffle could be divided into two segments with a naturally deep resting pool between them.

The short segment of the riffle upstream of the erosion pool was lined with approx. 60 m³ spawning gravel to reduce the slope from approx. 10‰ to 5–6‰. The downstream and longest segment of the riffle is approx. 110 m long and made of spawning gravel with a slope of 4–5‰. To protect the spawning gravel, three 2–3 m wide transverse bands of boulders were laid across the river, one at the beginning of the riffle, one in the middle and one at the end. These are effective in ensuring that the current cannot catch hold of the gravel and cause it to move.

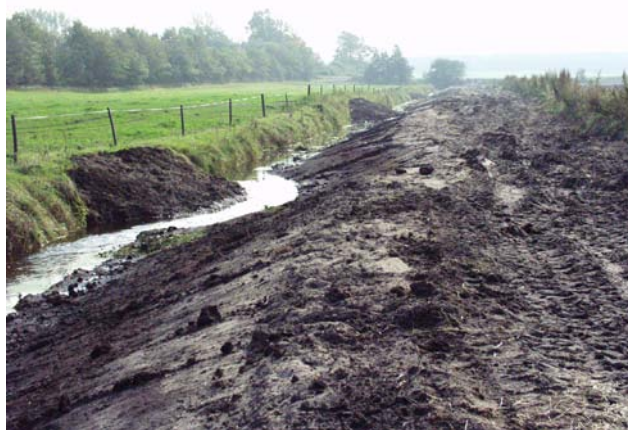
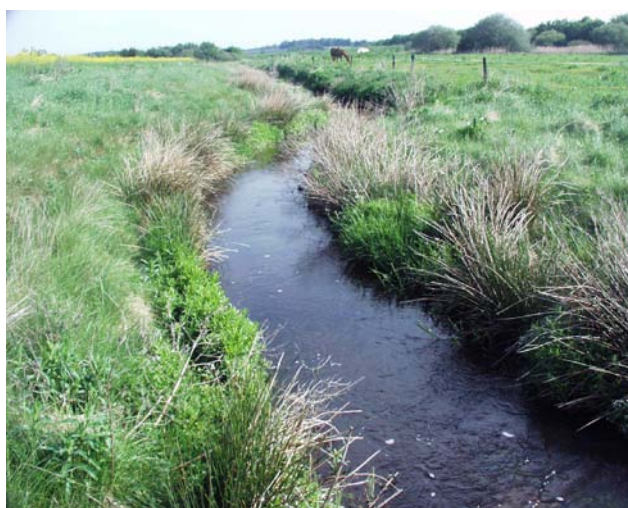
The fish farm, which had a feed quota of 43 tonnes per year, was closed down. The weir was removed, and the feed canal filled up with earth. A lake was established in the former fish ponds. The 560 m long dead reach of the river was restored with minor meanders in its own trajectory. In addition, spawning gravel was laid out, and steep banks were flattened (see the project drawings on the next page).

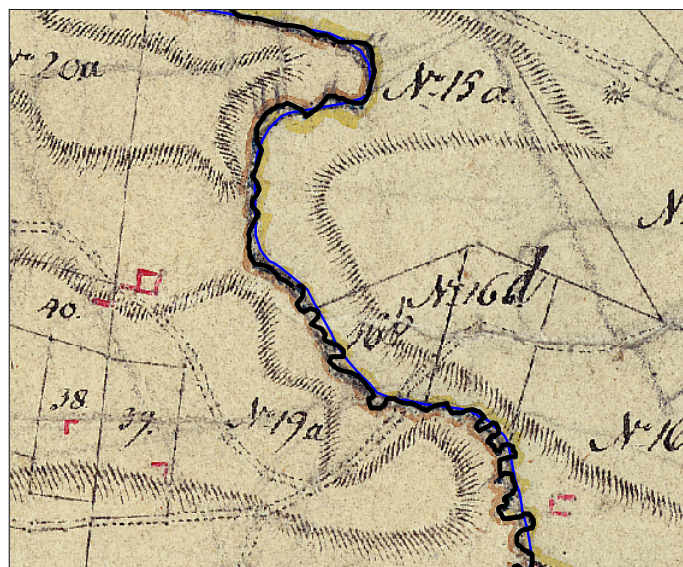
Map of the river Damvad at Toppevad Bridge drawn in 1818. The river trajectory at that time is drawn in black and the present trajectory in blue. Illustration prepared by Mogens Lindhardtzen, Frederiksborg County.

As is apparent from the old map drawn in 1818, the river Damvad originally followed a clearly meandering course through the narrow river valley. In connection with the project a similar meandering course was constructed. It was not possible to re-establish the original meanders along the segment running along the residential gardens at Toppevad Bridge and the approx. 100-m segment downstream of the bridge due to the presence of buildings or because the terrain had been levelled.

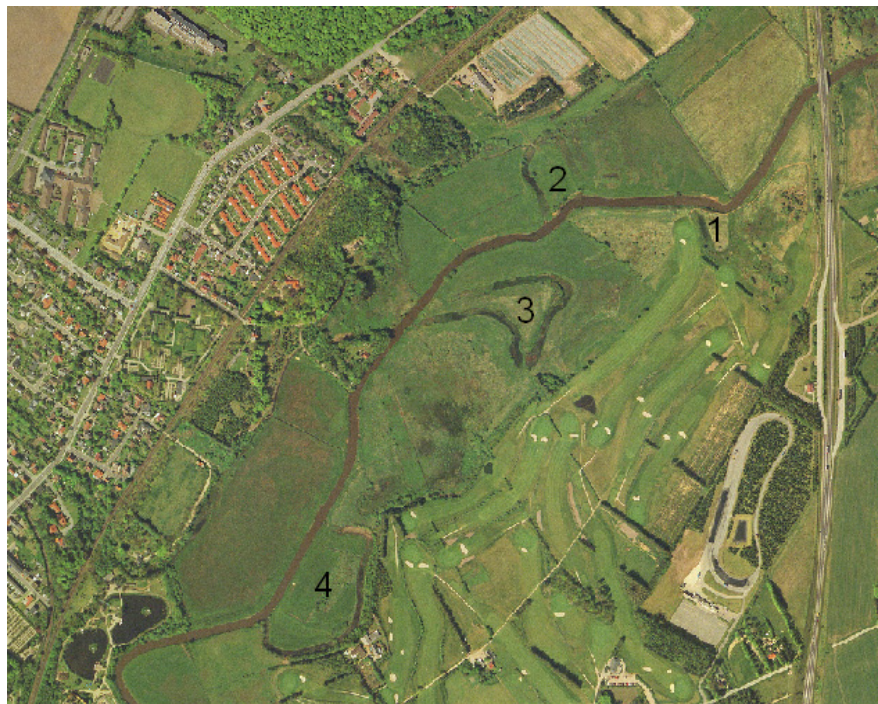
Aerial photograph of the project area prior to re-meandering of the river Varde. The location of former meanders 1–4 is indicated.

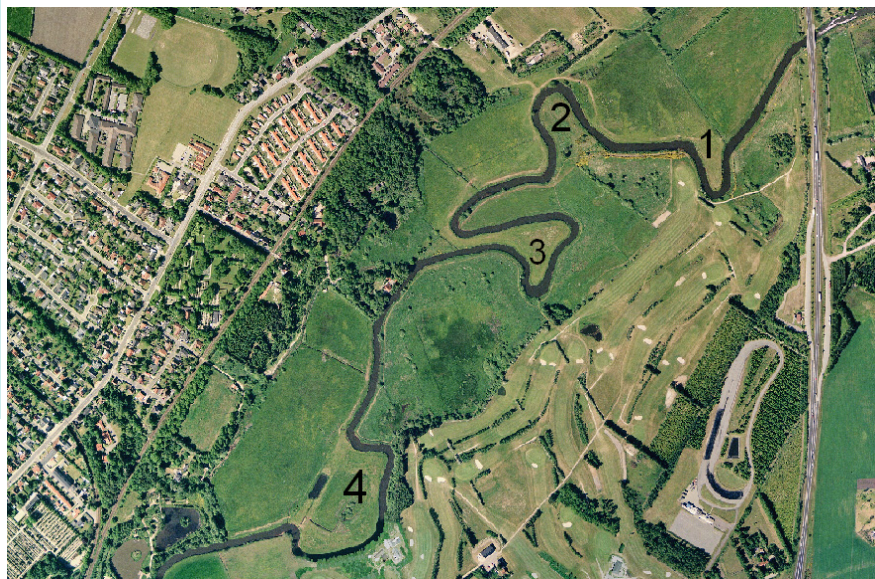
Aerial photograph of the river Varde after completion of re-meandering

The project was completed in 2000 with the opening of meanders 2 and 4 without further drama. In all, some 60,000 m³ of earth and mud had been excavated, moved and deposited, 11 spawning grounds consisting of in all 1,500 m³ of gravel had been established, and the banks in front of a single house on the edge of meander 3 had been protected with 600 m³ of stones.

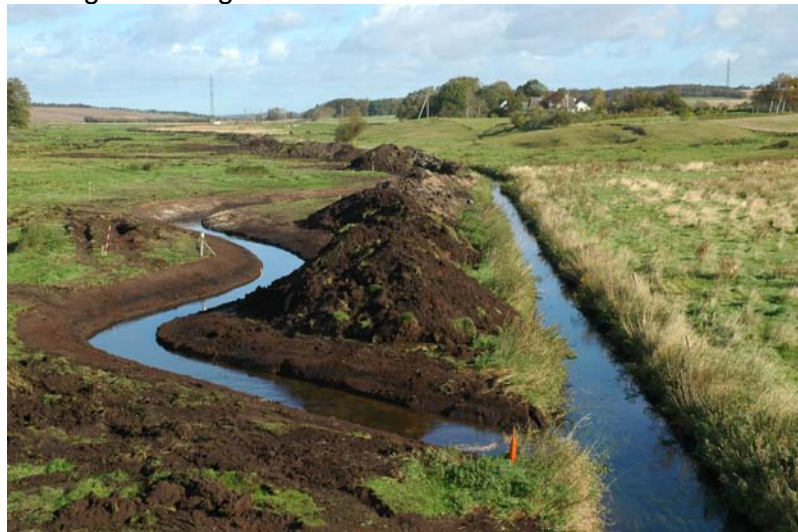
The meanders during excavation

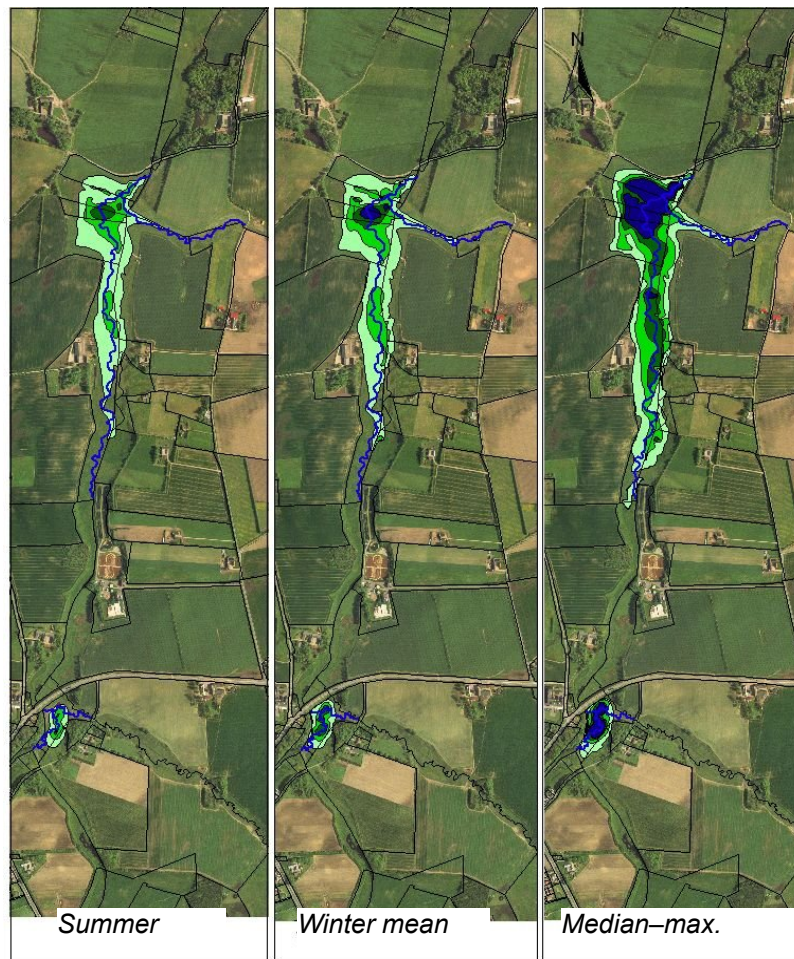
Wetland at Års.
 Drainage level

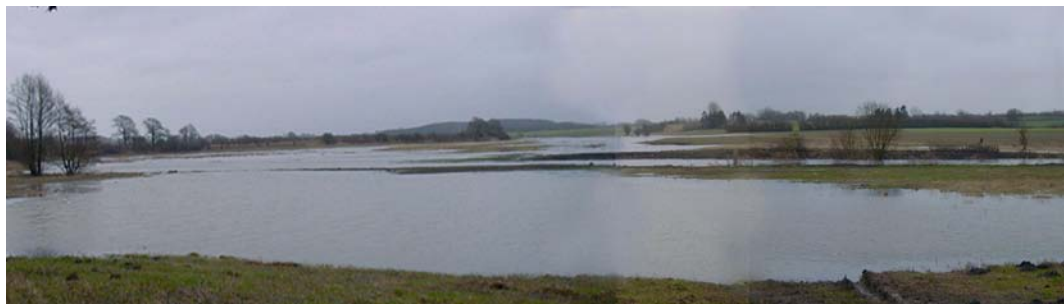
Flooding

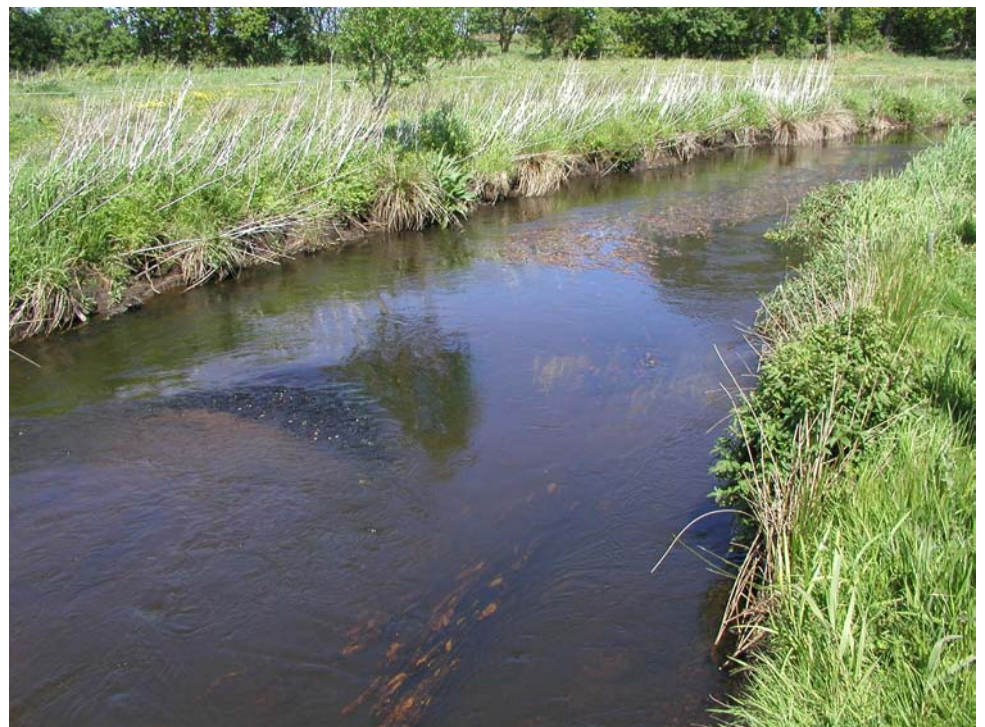
Example of the design of a spawning ground in the river Gels at Bevtøft

The project was carried out in autumn 1989. It started at Bevtoft Mill, where a 60 cm high fall was levelled out. From the mill and alongside Bevtoft, a 1,340 m long straight section of river was restructured to a 1,850 m long meandering reach. In addition, 18 spawning grounds were laid out. In order to approach conditions in a natural river, deep pools were established in the meander bends and shallow riffles in the straight sections between bends. At the same time the river's profiles were reshaped with flat beds on the inner side of the meander bends and sloping beds on the outer side.

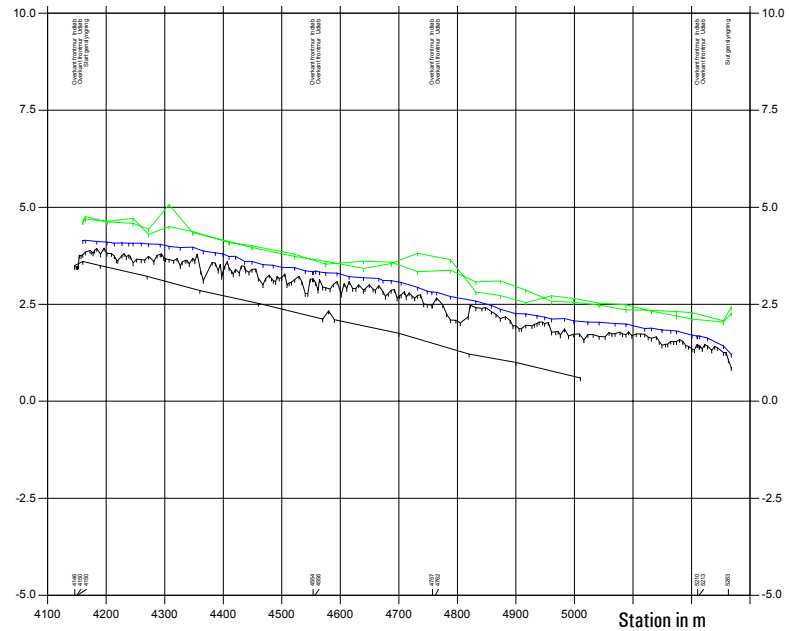
Height above Danish
Zero Level in m

Figure showing the river valley in green, the river level in blue and measurements of the bed before and after digging the new course in 2001

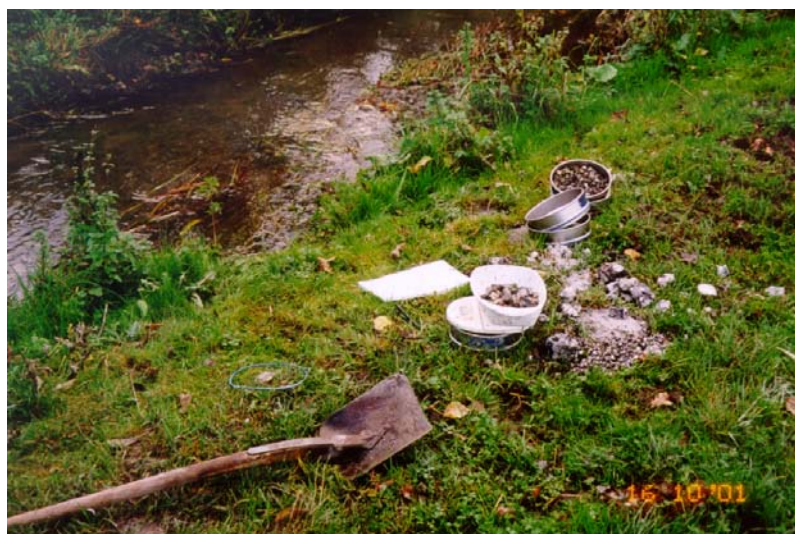
Prior to restoration, stone samples were collected in the project reach and an upstream reach to determine the size of the spawning gravel. These stone samples were sieved on site. The variation was considerable, however, and it was necessary to collect at least 10–15 samples.

Determination of stone size

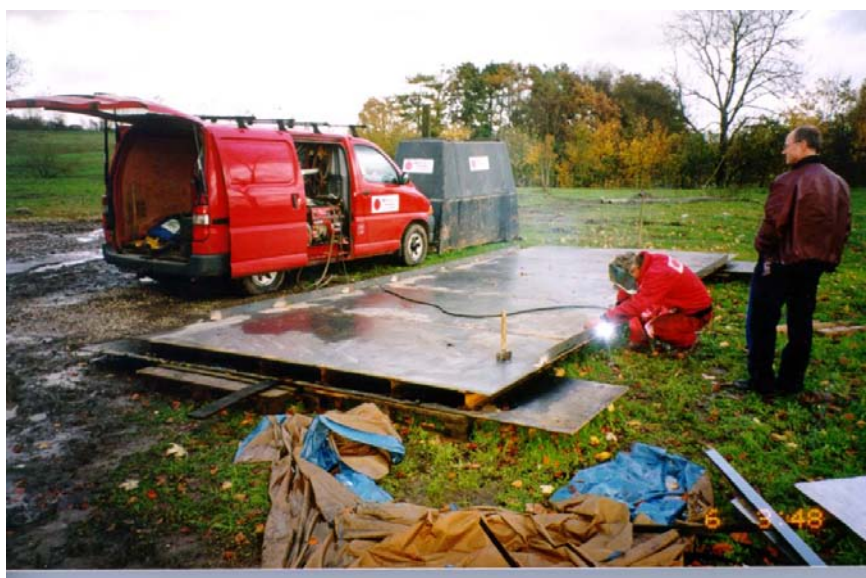
Welding the bridge. The bridge is moveable and only lies on the two plates seen beneath each end. After positioning the bridge surface is covered with 5 cm of soil.

In order to ensure the cattle as easy access to the meadow as possible, two extra iron bridges were established. These had no foundations but had an approx. 4 m² iron plate welded on each end. The advantage of this method is that the bridge is easy to move with an excavator if the river changes course.

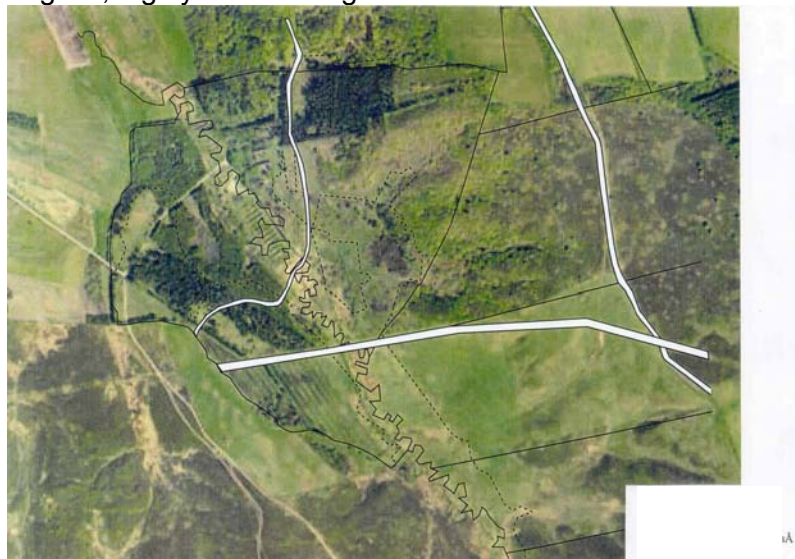
The original meandering course of the river Bruså drawn on an aerial photograph

The fish farm was established in 1958 on the site of a former water mill. The mill had been built sometime between 1816 and 1880. A map dated 1880 shows the water mill and a major millpond. It can also be seen that most of the river in the project area had already been straightened at that time. In contrast, the 1816 map shows the original, highly meandering course of the river without watermill.

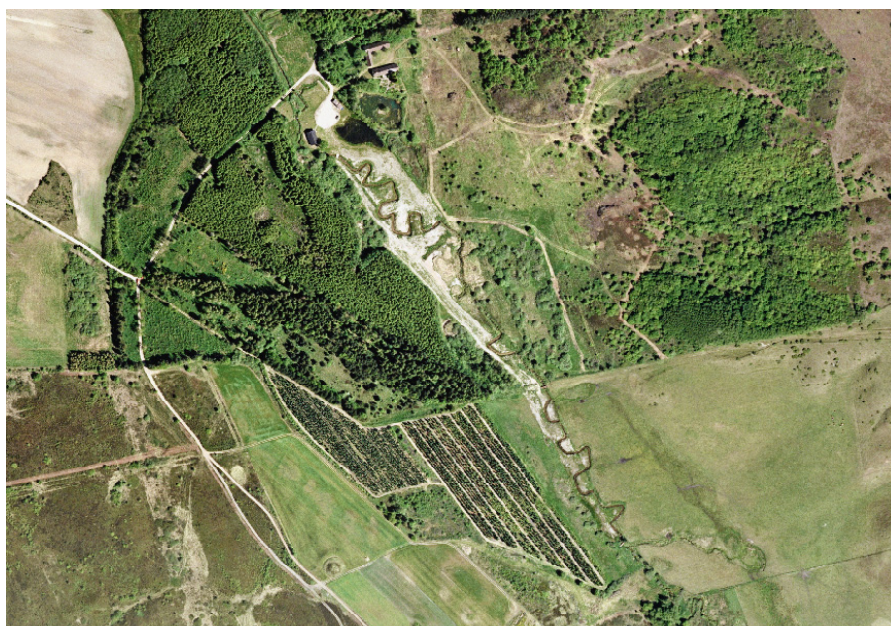
Aerial photograph taken after re-meandering

The fish farm site was levelled, and a new river was dug through the area. The fish ladder/weir was removed. The new reach merged with the existing course at the location of the former fish ladder but at an elevation corresponding to downstream reach. The two regulated reaches were filled up with earth. The new reach had the greatest slope, and a number of spawning grounds were established in it. The part of the fish farm site located downstream of Hylkærvej road (see the previous aerial photograph) was only levelled by the owner himself. Spawning grounds were established from the fish ladder to approx. 50 m downstream of Hylkærvej road.

Part of the old river course upstream of the fish farm was reused as the physical conditions were good and the width was harmonic. The occasional new meander was dug in this reach. There was slightly less fall available over the upper reach and hence only a couple of spawning grounds were laid out. The whole of the regulated reach was filled up with earth. The new course of the river Brusă is shown in the aerial photograph above.
